## Frame Inspection Report

**Client:** Sample Report

**Date of the Inspection:** 2 December 2021 **Time of Inspection** 3.30pm

**Frame :** Steel Frame and Roof Trusses constructed by Hello Homes

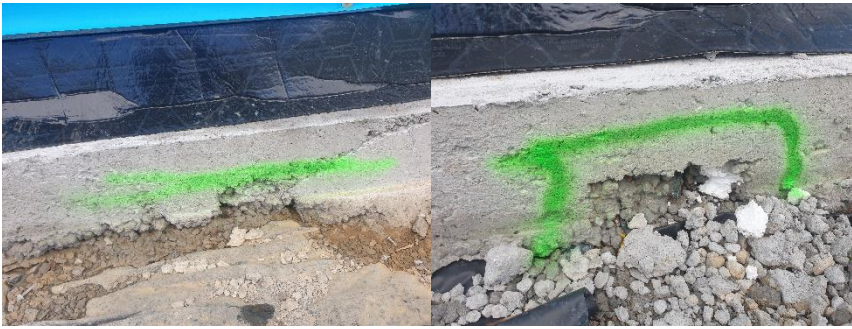
- Builder cold joint and voids in slab edge outside rear main bedroom left side ensuite slab edge. Void is required to be patched with engineer specified high strength grout.
- Large void and bar chair pod debris in slab edge left side main bedroom. Clean out debris cut back bar chair and rectify slab edge with high strength grout.
- Voids in slab edge compromise the structural building element and should be assessed by an engineer and a Form 15 Aspect Certificate / Scope of Works provided. After repairs the engineer should sign off to confirm the slab repairs meet structural building requirements.

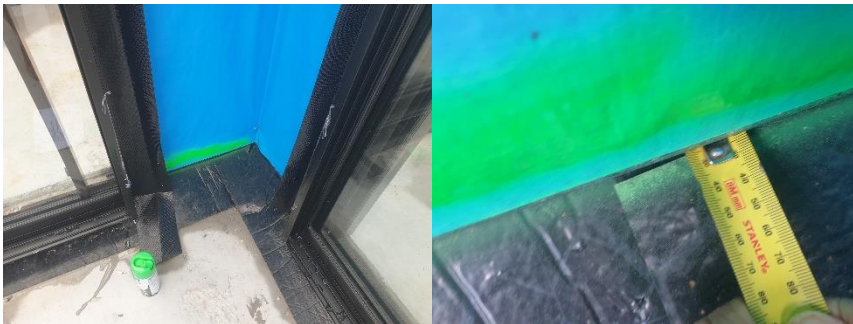
- Frame on right side of Hallway sliding door overhangs slab in excess of tolerances requirement 15 mm maximum for 90mm frame overhangs slab by 17 mm to 25 mm in corner.

QBCC Standards & Tolerances Standard Section 5.11

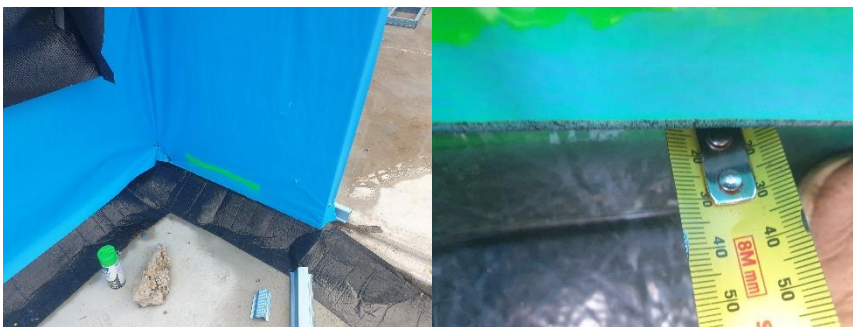
- Frame on left side of Dining Room sliding door overhangs slab in excess of tolerances requirement 15 mm maximum for 90mm frame overhang slab by 20mm in corner.

QBCC Standards & Tolerances Standard Section 5.11

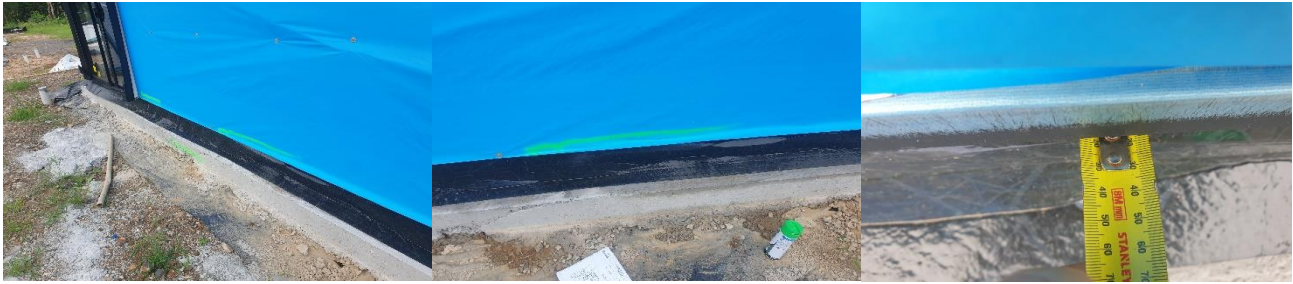
- Frame on Main Bedroom external wall section overhangs slab in excess of tolerances requirement 15 mm maximum for 90mm frame overhang slab by 20mm mm in corner QBCC Standards & Tolerances Standard Section 5.11

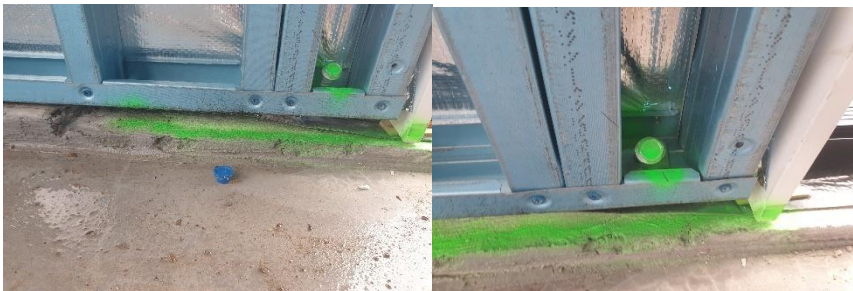
- Frame left side of Main Bedroom Ensuite sliding door unsupported for 300mm ensuite sliding does not meet QBCC Standards & Tolerances Standard Section 5.4
- Builder anchor tie-down bolt and washer are not installed correctly on left side of ensuite sliding door opening QBCC Standards & Tolerances Standard Section 5.9

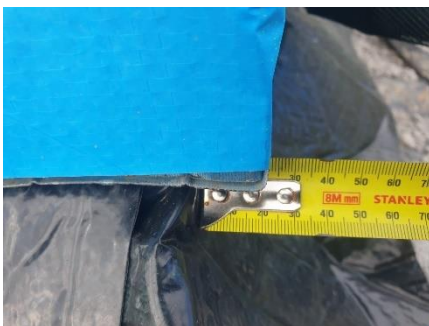
- External wall frame on left rear corner of Main Bedroom Ensuite overhangs slab edge in excess of tolerances requirement 15 mm maximum for 90mm frame overhangs slab by 20mm exceeds QBCC Standards & Tolerances Standard Section 5.11

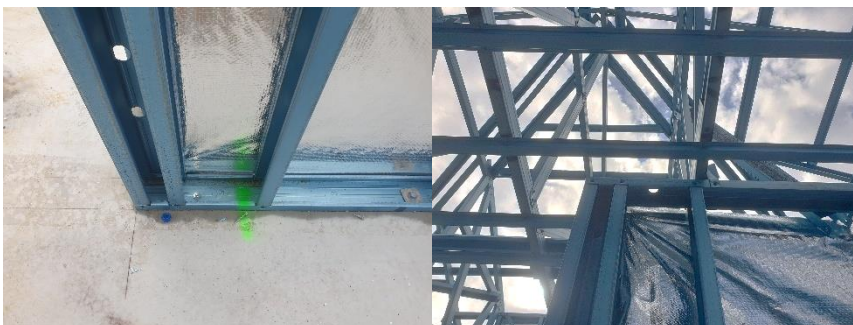
- Install anchor bolt in bottom plate directly adjacent stud right side of Study opening to maintain tie down as tie down point of gable roof truss directly above.

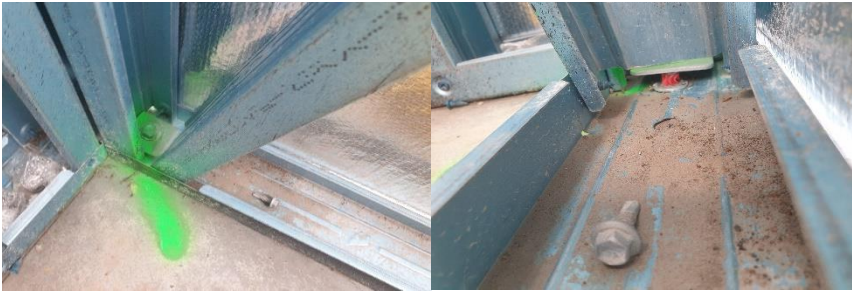
- Gap under cyclone washer incorrectly installed on anchor bolt bracing panel rear left corner of Bedroom 4 sliding door opening

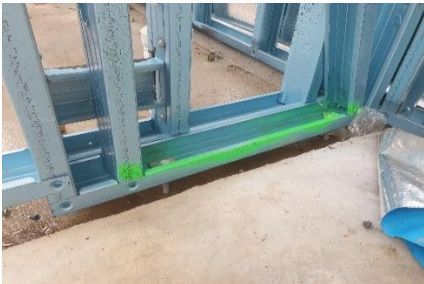
- Base of wall frame bracing panel internal right side of Bedroom 4 ensuite door opening should be supported. Section of wall is a structural bracing element base plate of frame is required to be supported by high strength grout.
- Cyclone anchor bolts either side of bracing panel right side Bedroom 4 ensuite wall frame do not meet structural design requirement. Bracing panel bolts should be embedded in concrete slab not in floor slab grouting / overlay

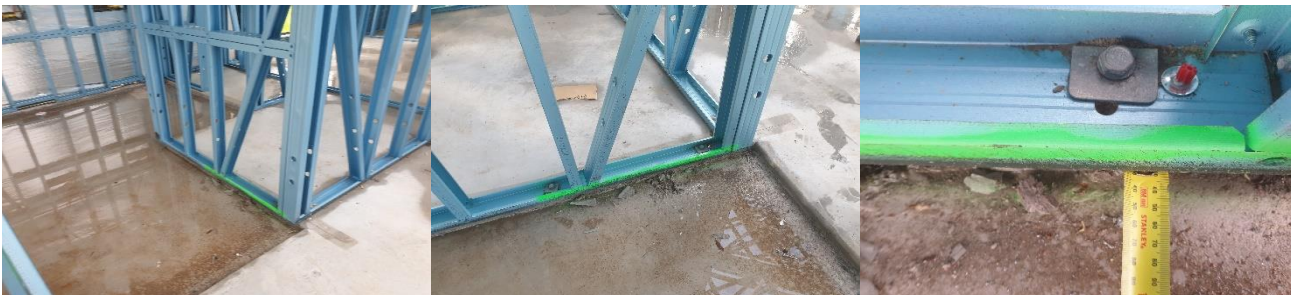
- Bracing panel wall frame structural building component overhangs slab in Rear Bathroom by 20 mm. Slab edge support / repair for frame with structural grout required. exceeds QBCC Standards & Tolerances Standard Section 5.11

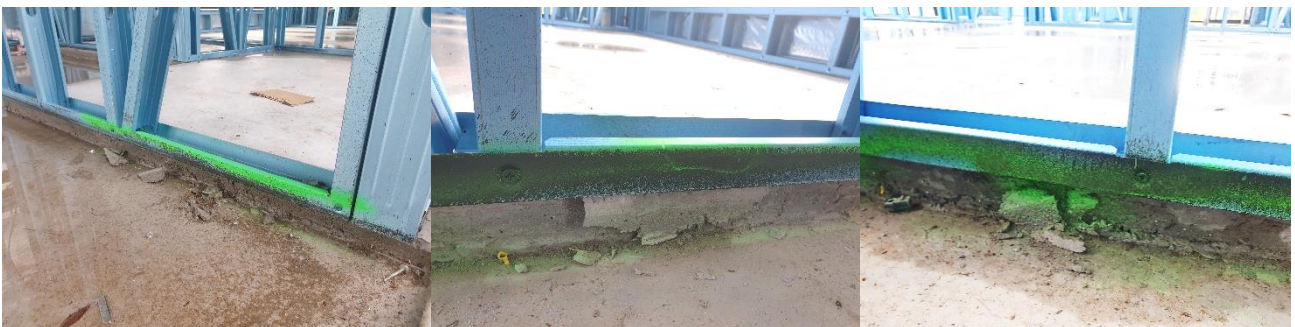
- Anchor bolts on ends of bracing panel slab edge Rear Bathroom damaged. Slab edge / anchor point requires rectification to meet structural building requirement.

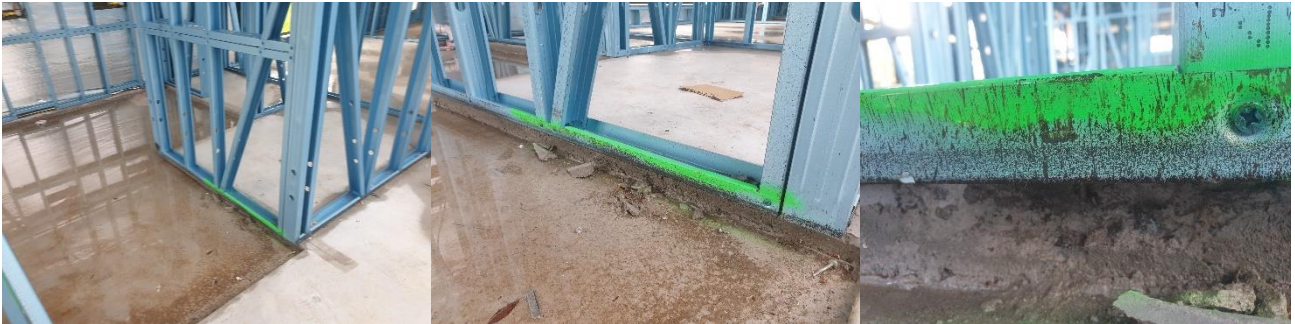
- Main Bedroom Ensuite damage to slab edge where anchor bolt installed on bracing panel side wall adjacent opening from master bedroom. Wall frame bracing structural component overhangs slab edge by 30mm exceeds building tolerance. Wall frame slab edge should be supported with high strength grout / structural bracing component.

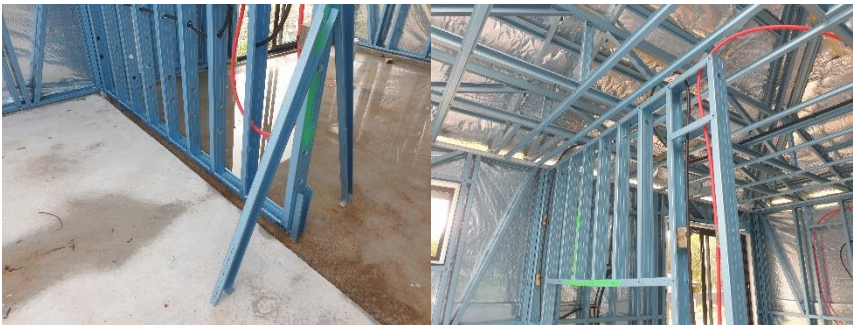
- Wall frame between Master Bedroom and Ensuite recess in wall top head bowed down and areas of damage to top plate not tied to ceiling diaphragm. Base of wall unsupported.

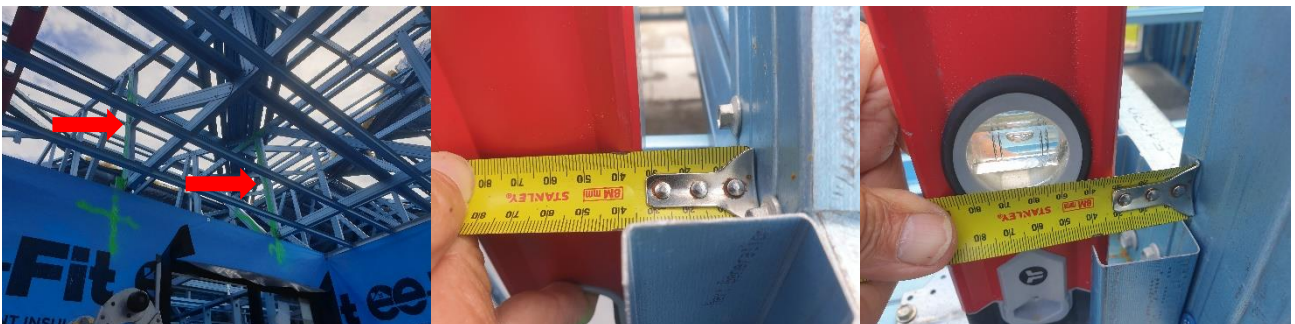
- 2 Gable roof trusses above Study window adjacent Master Bedroom 30mm out of plumb exceeds building tolerances requirement / rectify

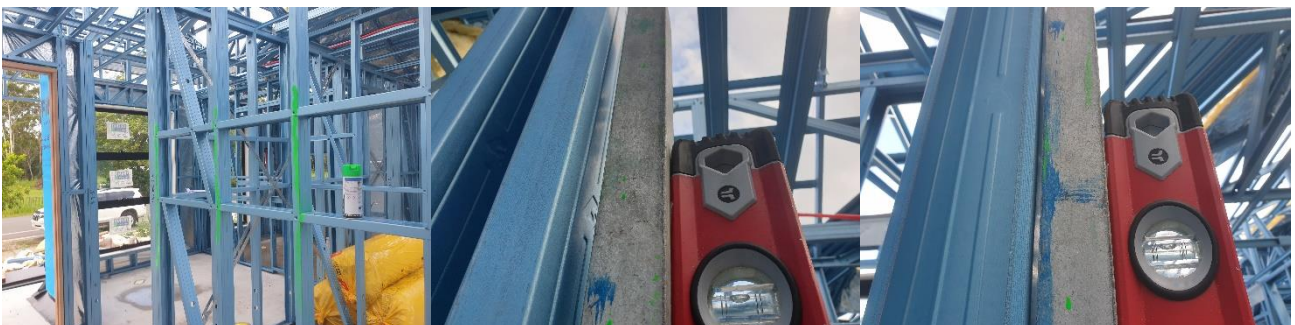
- Corner to middle of Hallway / Bedroom 4 robe wall out of plumb exceeds building tolerance 4 mm in 2 meters

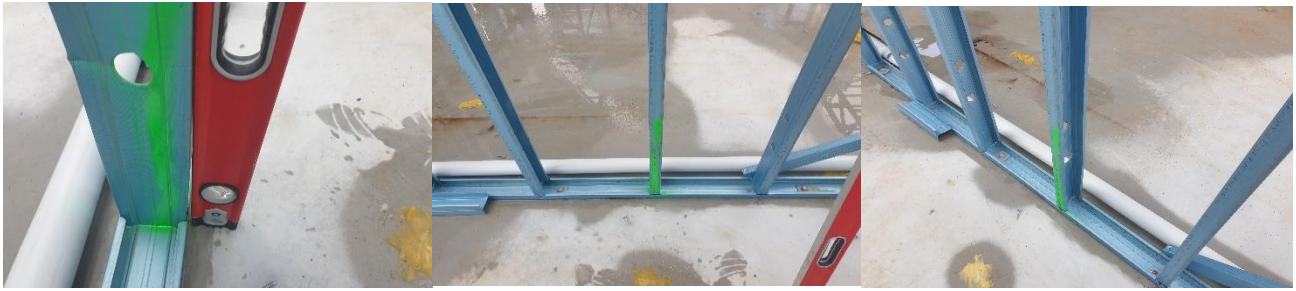
- Stud base damaged on Hallway / Garage wall damaged requires repair / bow in base of stud

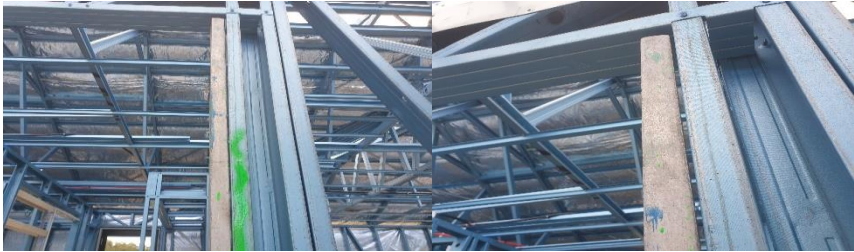
- Bow in corner of opening Hallway / rear Garage door. Corner stud variation exceeds 4 mm in 2 meter building tolerance standard

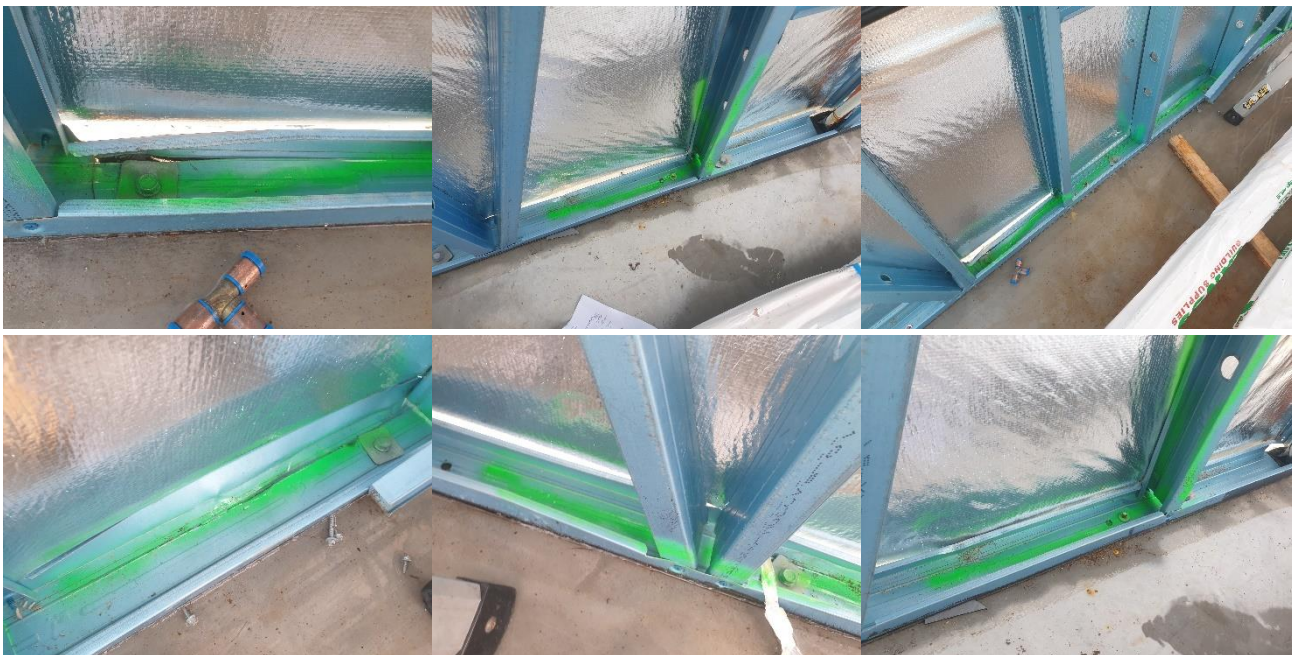
- Damaged garage wall framing top / bottom plates wall out of plumb. Splits in framing right side garage wall. Due to the extent of damage to top, bottom plates, studs and noggings wall would need to be replaced. Damaged structural component splits in metal frame.

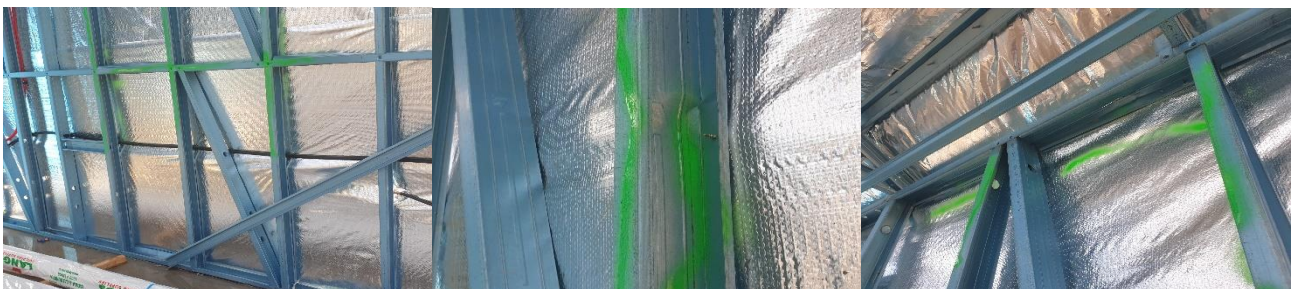
- Various splits and damage to wall plates, studs & noggings garage side wall

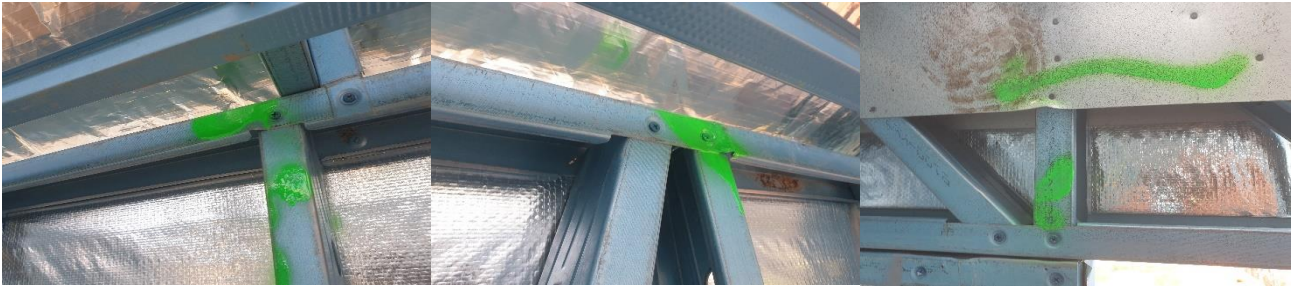
- Multiple kinks and damage to wall framing and face plate on left side of garage door head

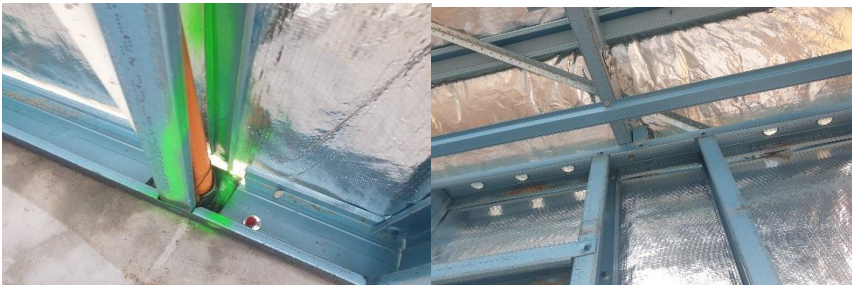
- Stud front right side of garage wall direct support under roof truss above cut out and not correctly attached to bottom wall frame additional stud should be placed directly beside

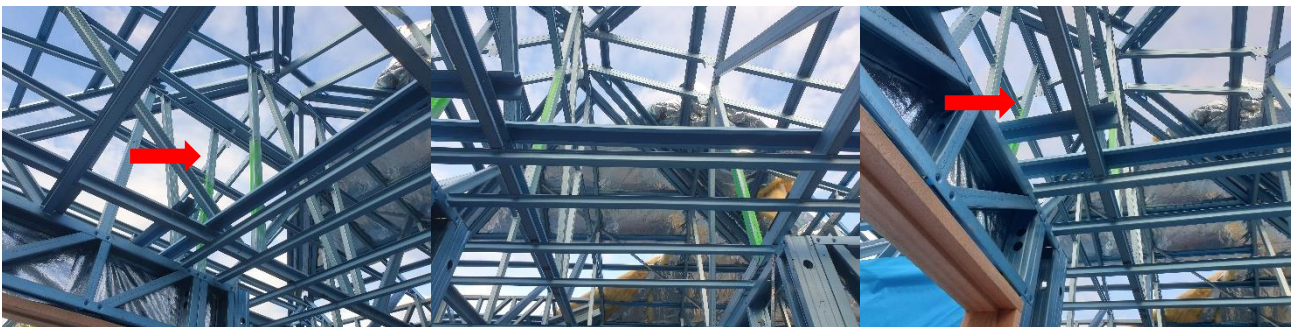
- Gable roof trusses, 3 over front Study / Bedroom 4 walk-in robe out of plumb

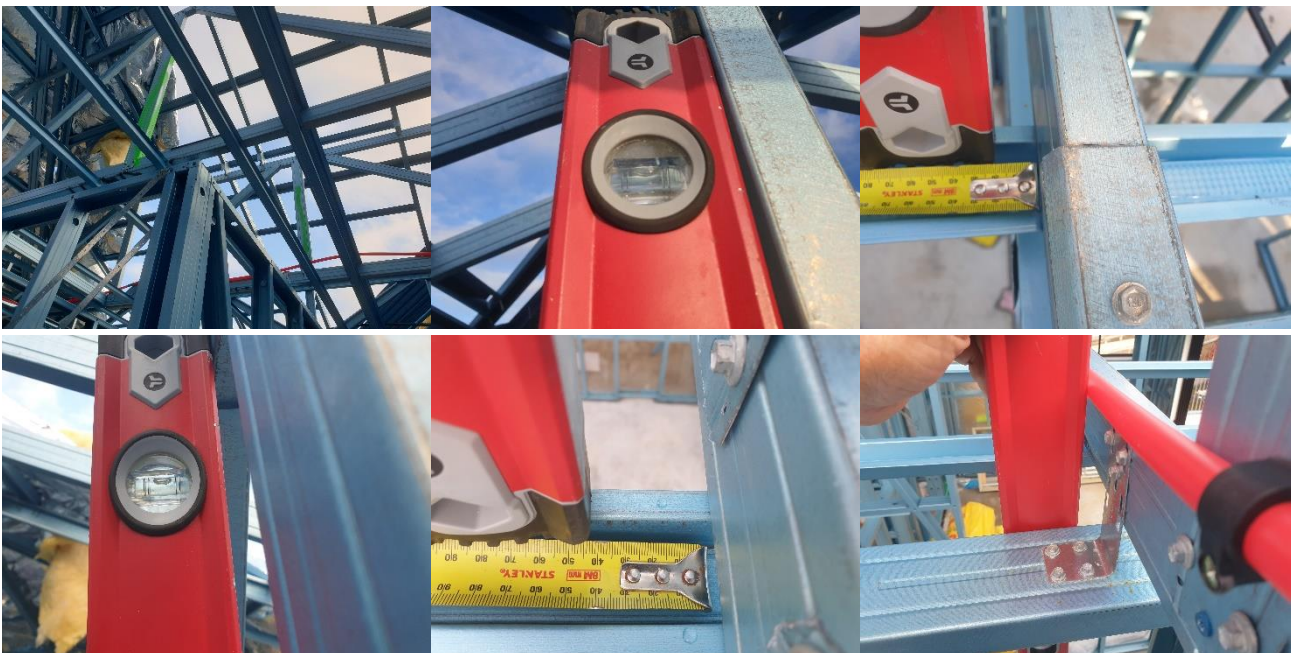
- Gable trusses over front study, Bedroom 4 & Walk in robe leaning out of plumb between 20mm and 40 mm

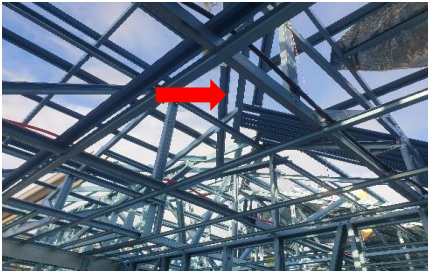
- Hip Valley intersection framing over above Front Entry incomplete valley missing

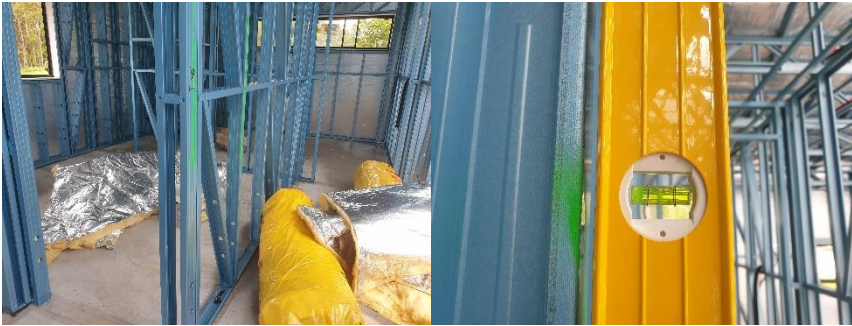
- Hallway rear wall frame out of plumb Bedroom 2

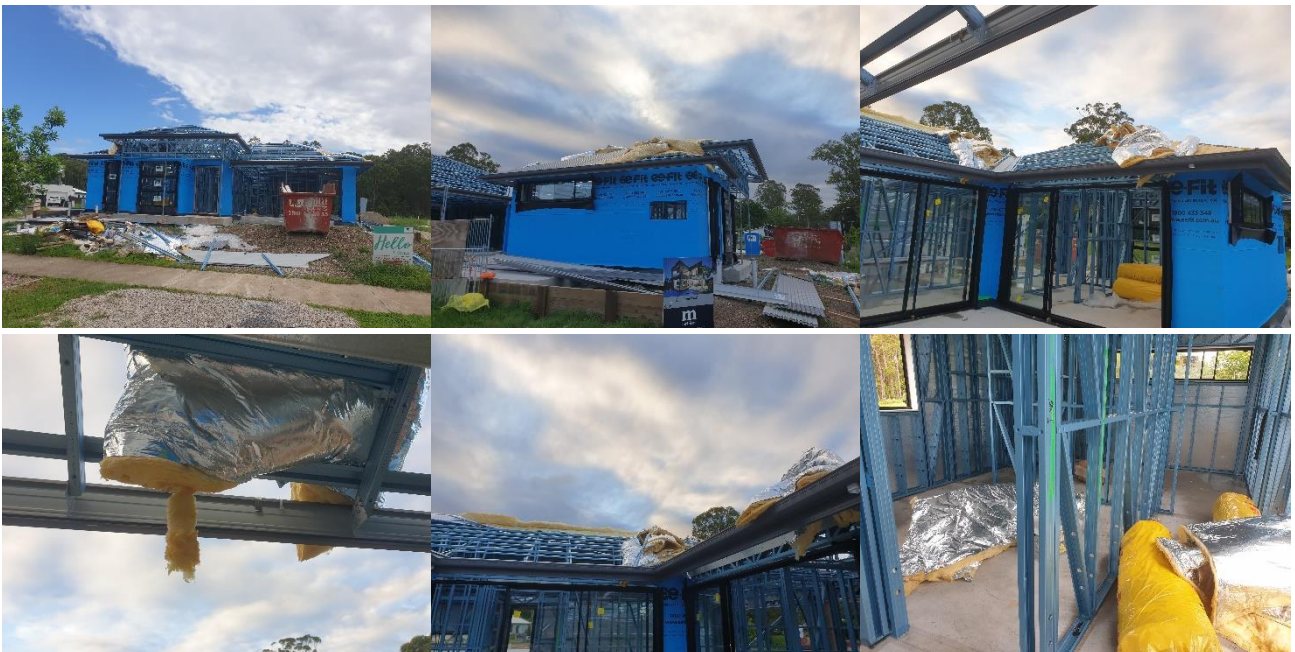
- Rolls of insulation and insulation on roof damaged and saturated from extended period of rain Damaged insulation on ridge. Insulation stored on site in rain bundled insulation rolls have water in them also. Any insulation damaged by elements or moisture will need to be replaced.
- Current installation would void Bradford warranty requirements.
