**Swimming Pool Inspection Report****Inspector :** Paul Bloomer**PSI Licence Number :** 100529**Terms of Inspection / Consultancy**

**Details of the Inspection****Client :****Invoice No :** 412152P**Address :** Yaroomba Qld 4573**Phone :****Email :****Date of the Inspection :****Time of Inspection :** 4.30 pm**Building Tenancy :** Residential**Pool Classification :** Private**Description of Pool Barrier / Pool Fence Inspected****Pool Safety Certificate :** Yes**Date of Issue :** 16 December 2014**Pool Fence Type :** Timber, Masonry, Glass & Aluminium**Access :** Acceptable**Structures In or Adjoining Fenced Area :** Owners Home, Public Footpath, Adjoining Property

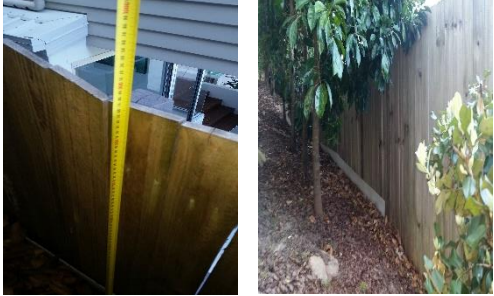
No	Item Location	Rectification	Photo
1	<p><b>Boundary Fence Left Side</b>                      Left side boundary fence non-compliant as it is less than 1200mm high</p> <p>Fence has gaps between bottom of palings and top of block wall left front greater than 100mm does not meet pool safety requirement</p>	<p>Fence would need to be raised to minimum 1200mm high to meet pool safety requirement.</p> <p>Gap needs to be reduced to less than 100mm to meet pool fencing regulations</p>

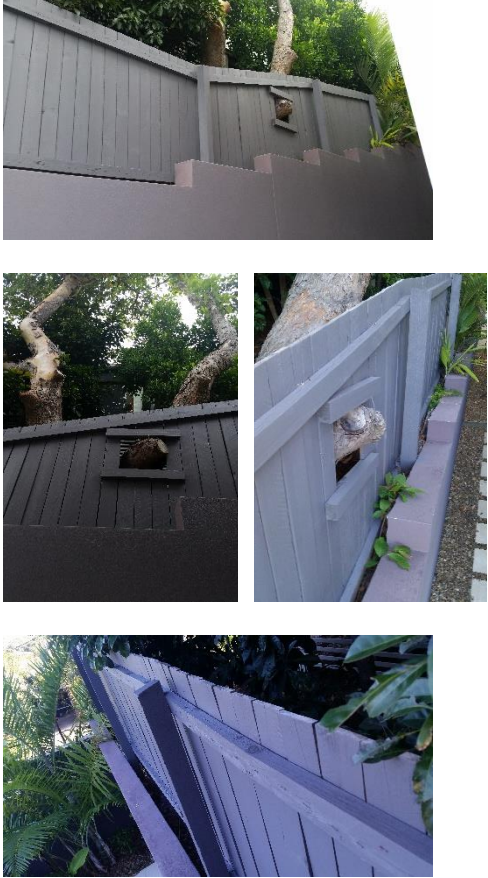
2	<p><b>Boundary Fence Left Side</b>                      Tree on left side of fence and protruding through is a climbable object in the non-climbable zone and fence is less than 1800mm high and has climbable elements on the inside in the non-climbable zone.</p>	<p>Fence would need to be modified to meet safety standards. 900mm denial section of fencing would need to be fitted on top of the block wall in a manner that meets pool safety requirements denying access to the pool via the top of the block wall. When entering the pool from the climbable area the top of the block wall can be walked on to the front where the height is less than 1800mm high allowing access to the pool</p>

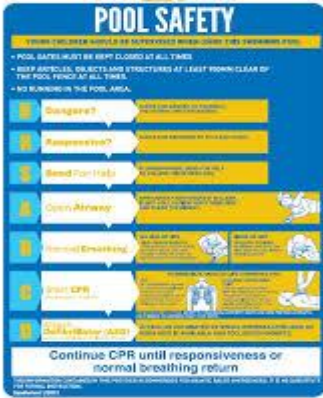
6	<p><b>Resuscitation Chart</b> Ensure resuscitation chart is displayed in a visible area. <b>Chart visible on property partially blocked by plant in front of it at time of inspection.</b> <b>See advisory information.</b> <b>Remove plant.</b></p>	<p>Display chart in an area adjacent to the pool near steps or wider pool edge where someone would be retrieved / removed from the pool. Chart should be visible from general pool area. Ensure chart displays 000 emergency number and resuscitation / chest compressions for adult and child.</p>
